Walk Audit Report

Dave Beal
Age Friendly Olmsted County
Family Service Rochester
December 17, 2023

Slatterly Park Walk Audit - 2023 Route Options

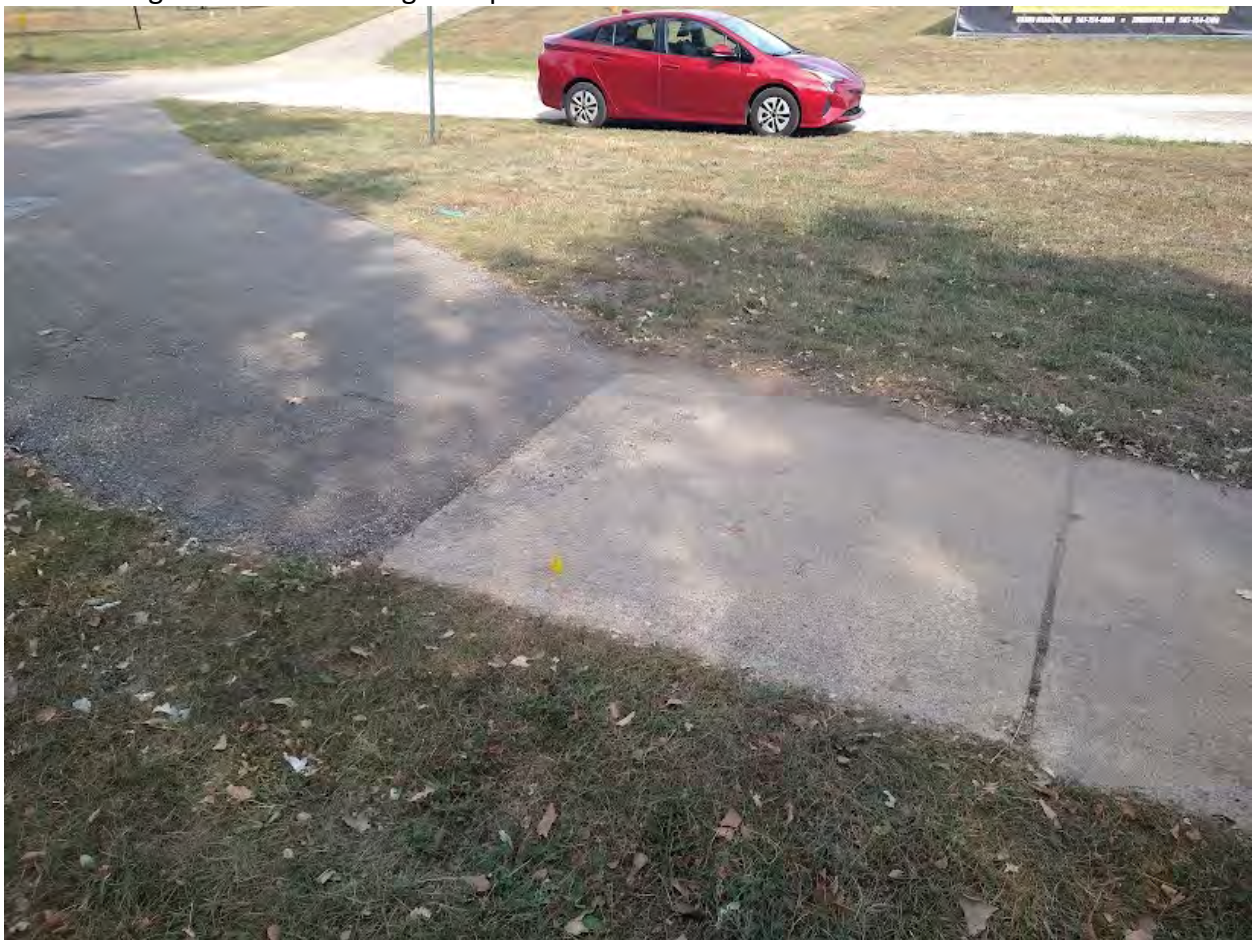
The multipurpose path narrows to a concrete sidewalk. The walkers were concerned about bike traffic riding this sidewalk along with pedestrians.

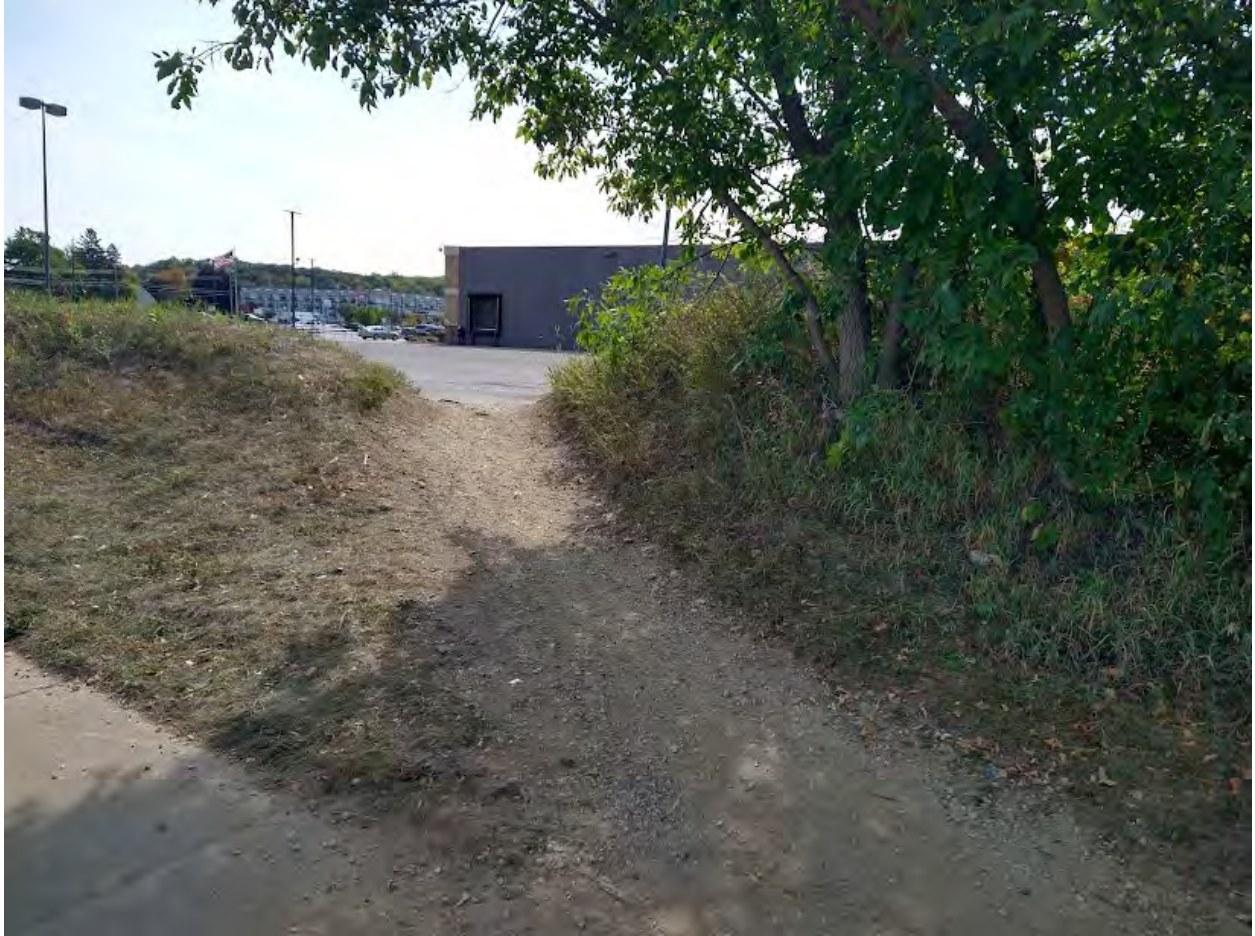
The sidewalk heading East to 15th Ave is narrow and overgrown with weeds. There is dirt washed on top of it. The walkers said "It feels like we shouldn't be here". The landscaping felt unmaintained and even the trees planted in the last 2 years were dying from drought. There was a lot of litter. There was a large berm separating the sidewalk from Cub Foods. A desire path headed over the berm to connect residents to the Grocery store. The Berm ran the length of the sidewalk until reaching 15th Ave.

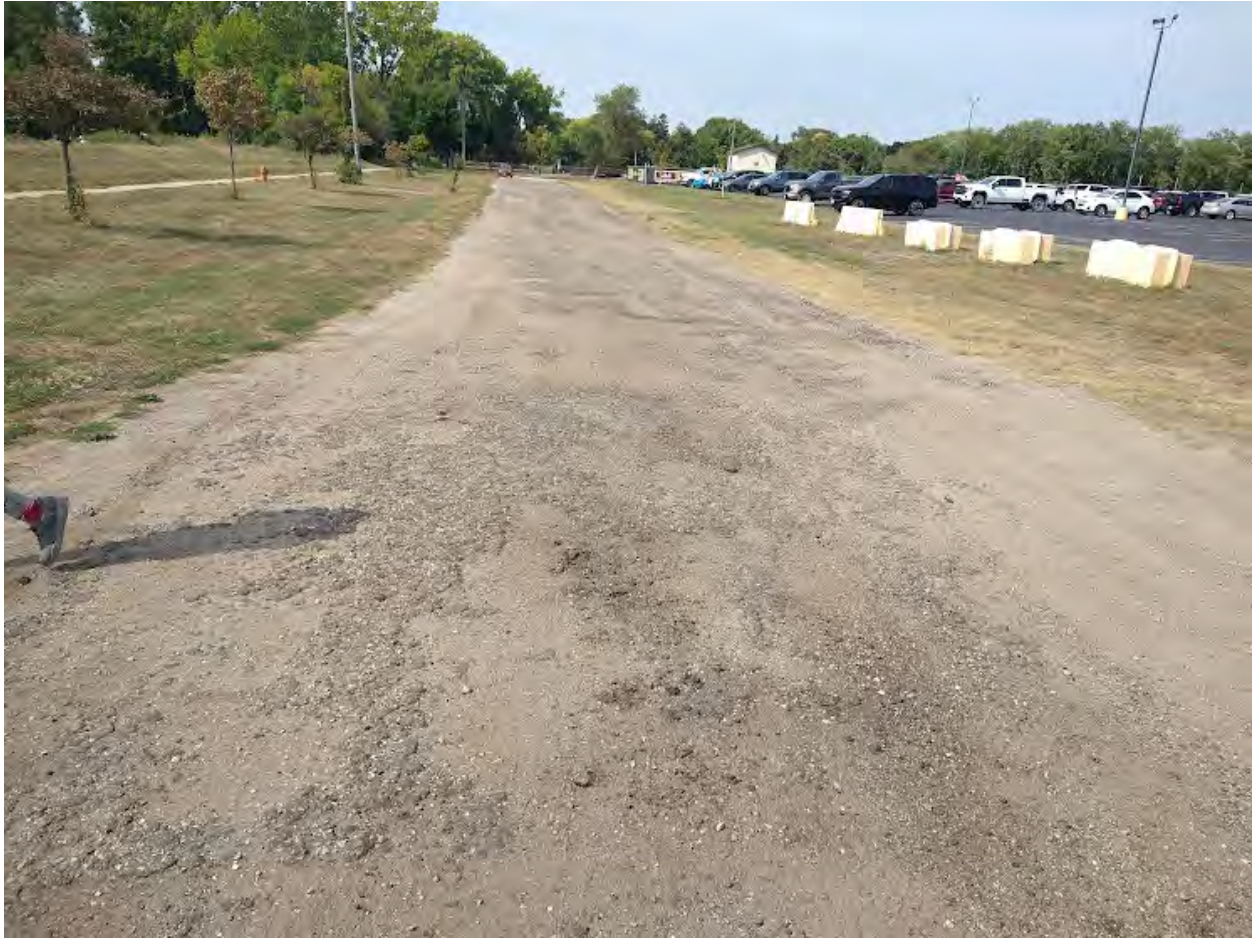
The sidewalk ran along side a street that appeared to be a public right of way (10th St). It is in rough shape and unsuitable for bicycle traffic or Pedestrians with the worn asphalt. It only leads to the park and is likely only used by Law enforcement and Parks Dept Staff however there was a private car parked here. This leads to the unloved feel of this section of sidewalk.

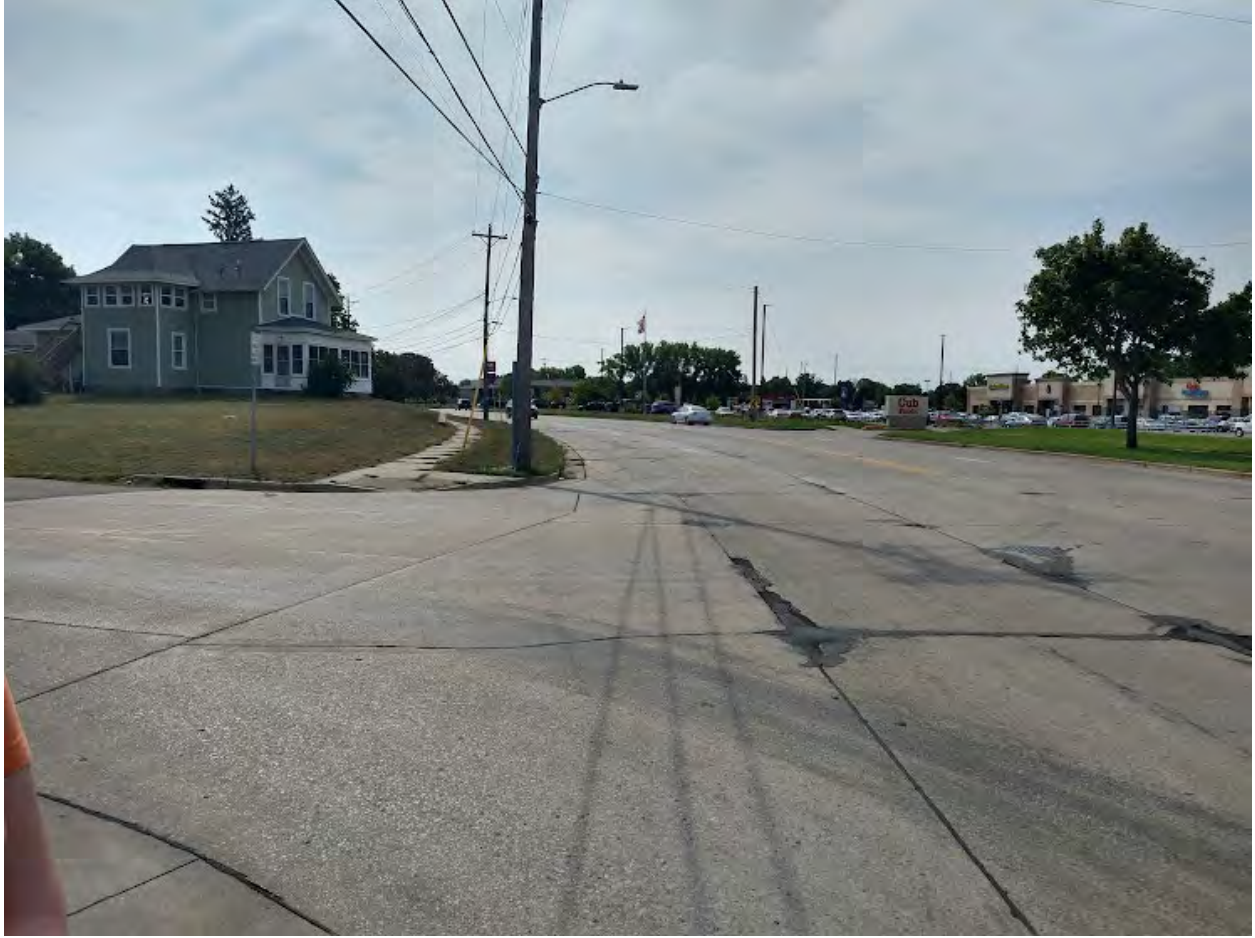
There was a covered bus shelter on 15th Ave in use.

We arrived at 15th Ave and witnessed 3 separate groups crossing the busy road here in less than 10 minutes. One was a woman with a child in a stroller heading to the store. We crossed here and found it very difficult to see around the bend in the road. Even when we thought the crossing was clear, a car turning onto 15th from a nearby parking lot had to stop in the road for us to finish crossing. The walkers thought this would be a good site for flashing pedestrian signals. With the bend in the road, this might not be the best tool. We witnessed cars driving at about 40MPH which is the posted speed limit here. We questioned the need for a 40mph speed limit when the road ends within a few blocks to the north.

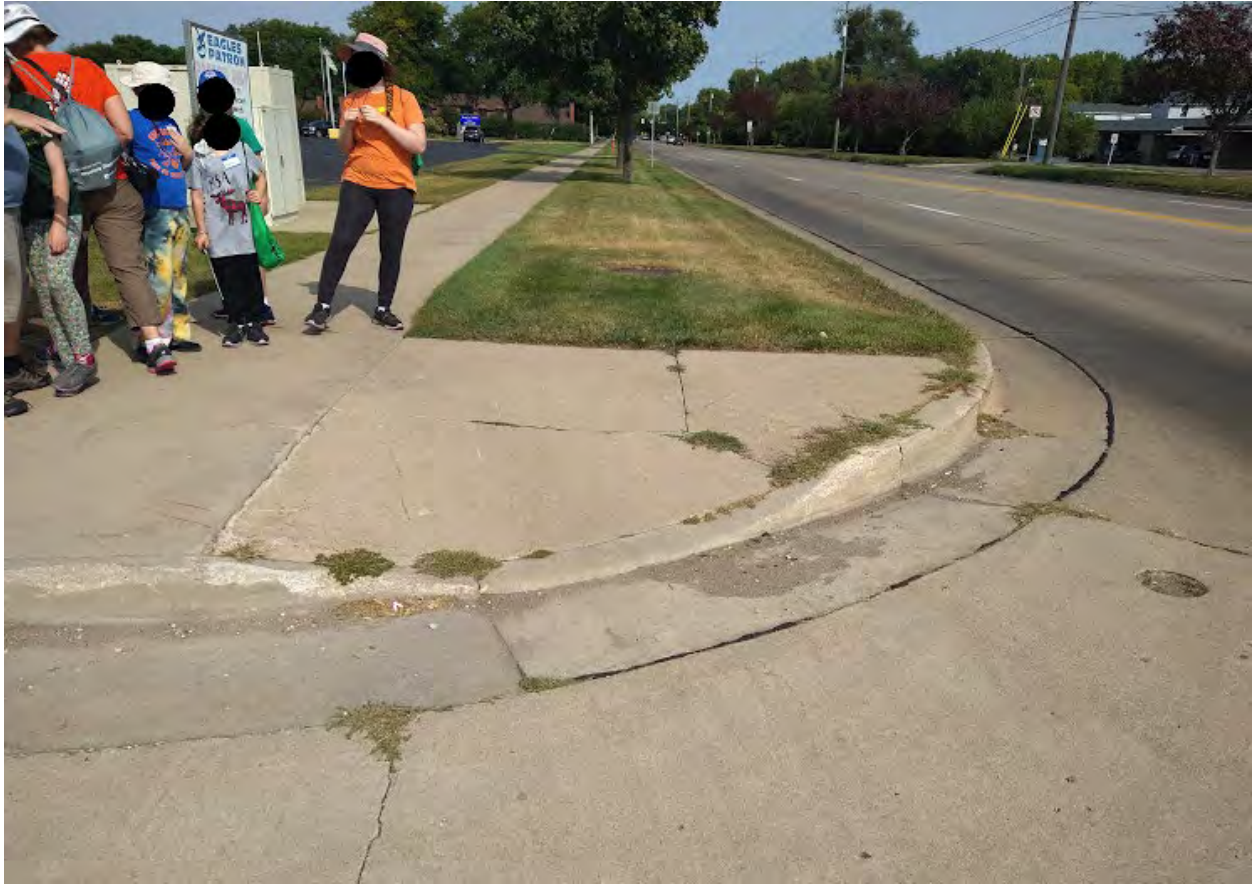
Section 2:

The sidewalks heading on both sides of 15th Ave were in good physical shape. The curb cuts were centered in the corner and lead directly into this busy street. There was evidence of scrapes from scooters bottoming out on the steep ramps.

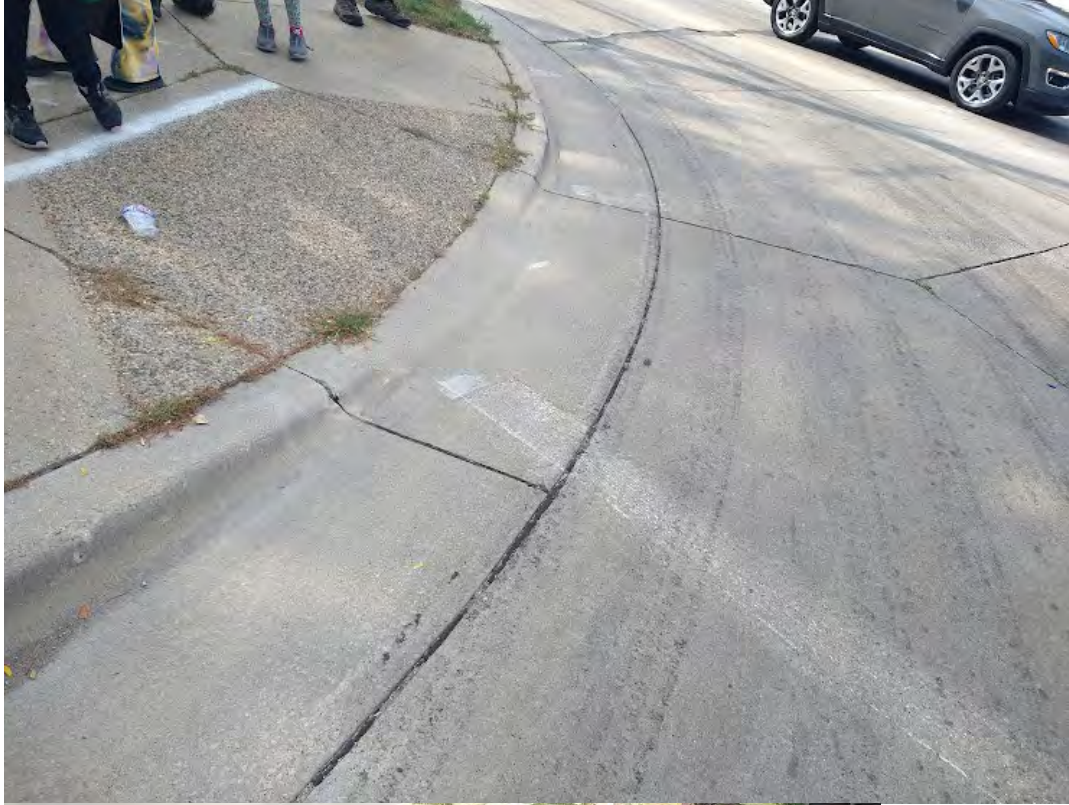
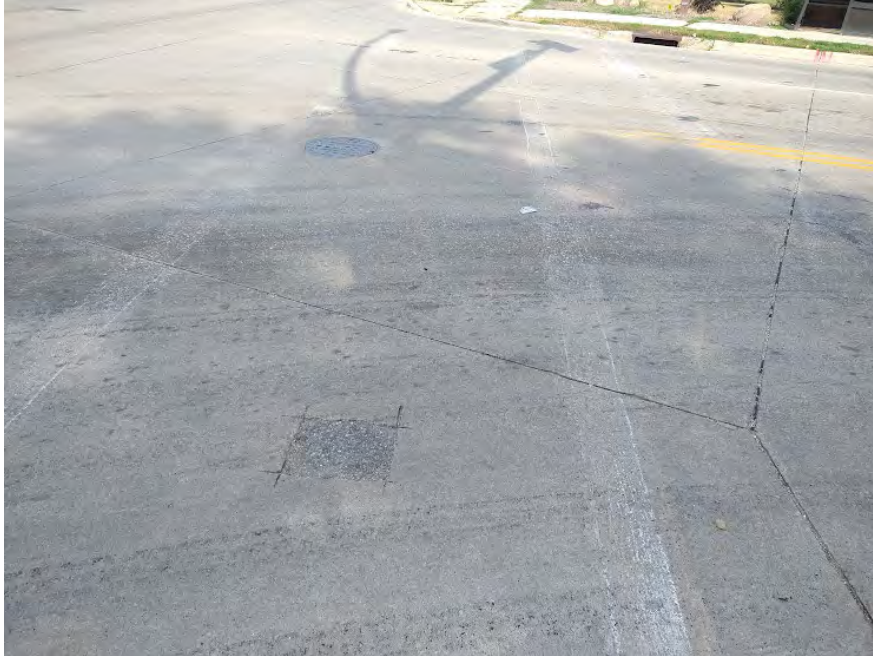
The intersection at 8 1/2th St and 15th Ave had a push-to-cross button. It was not an audible signal. The crosswalk lines were worn off and did not align with the curb cuts. The curb cuts were again diagonal and not easily navigated by people with a visual impairment. We had no issue crossing the street in time during the signal.
